NATIONAL TRANSPORTATION SAFETY BOARD

Computed Tomography Specialist's Factual Report

CEN17FA127

Location: near Chalmers, IN
Date: March 14, 2017
Time: 1546 eastern daylight time
Airplane: MD Helicopters 369FF helicopter, N530KD

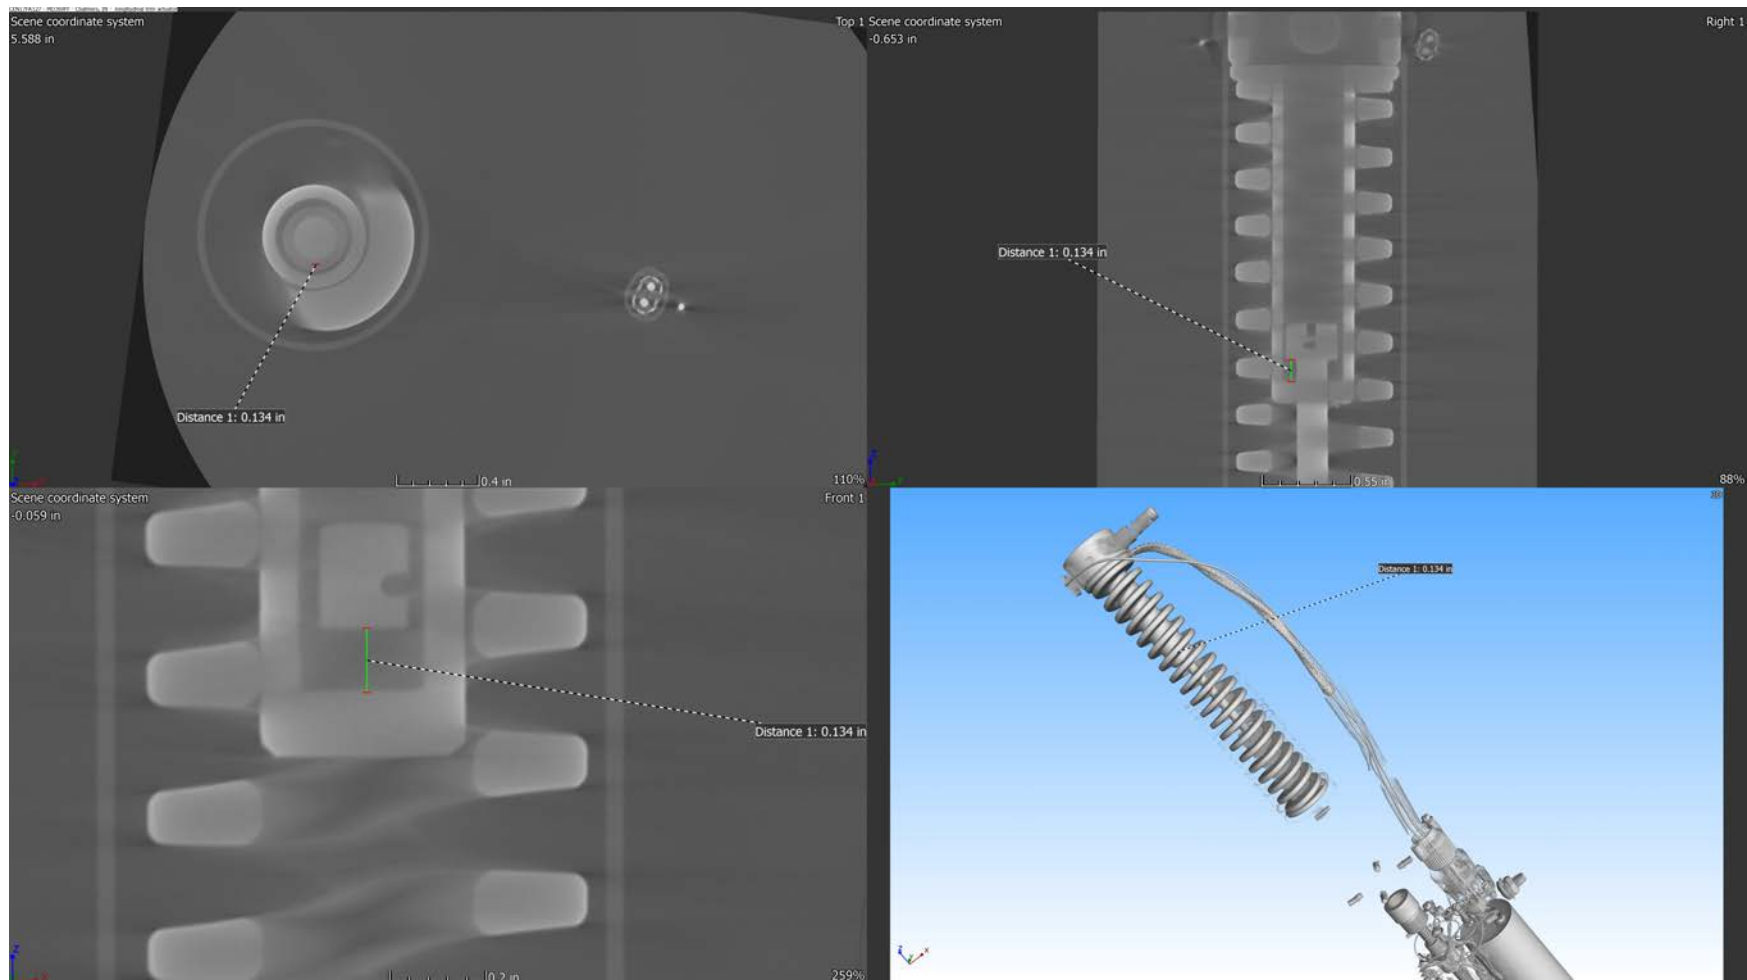
- there was a gap of 0.134 inches noted between the end of the actuator rod and the actuator spring cartridge end fixture;
- there were 2.724 inches of actuator screw thread between the actuator screw ball and the actuator screw base;
- there were no indications of failure within the actuator motor bearings or output gear train;
- there were indications of small clearances between the actuator motor wires and the motor ground terminal components and between the wires themselves;
- there were no indications of short circuits or other wiring damage within the actuator motor or circuit board wiring;

Figure 3
Longitudinal trim actuator – gap

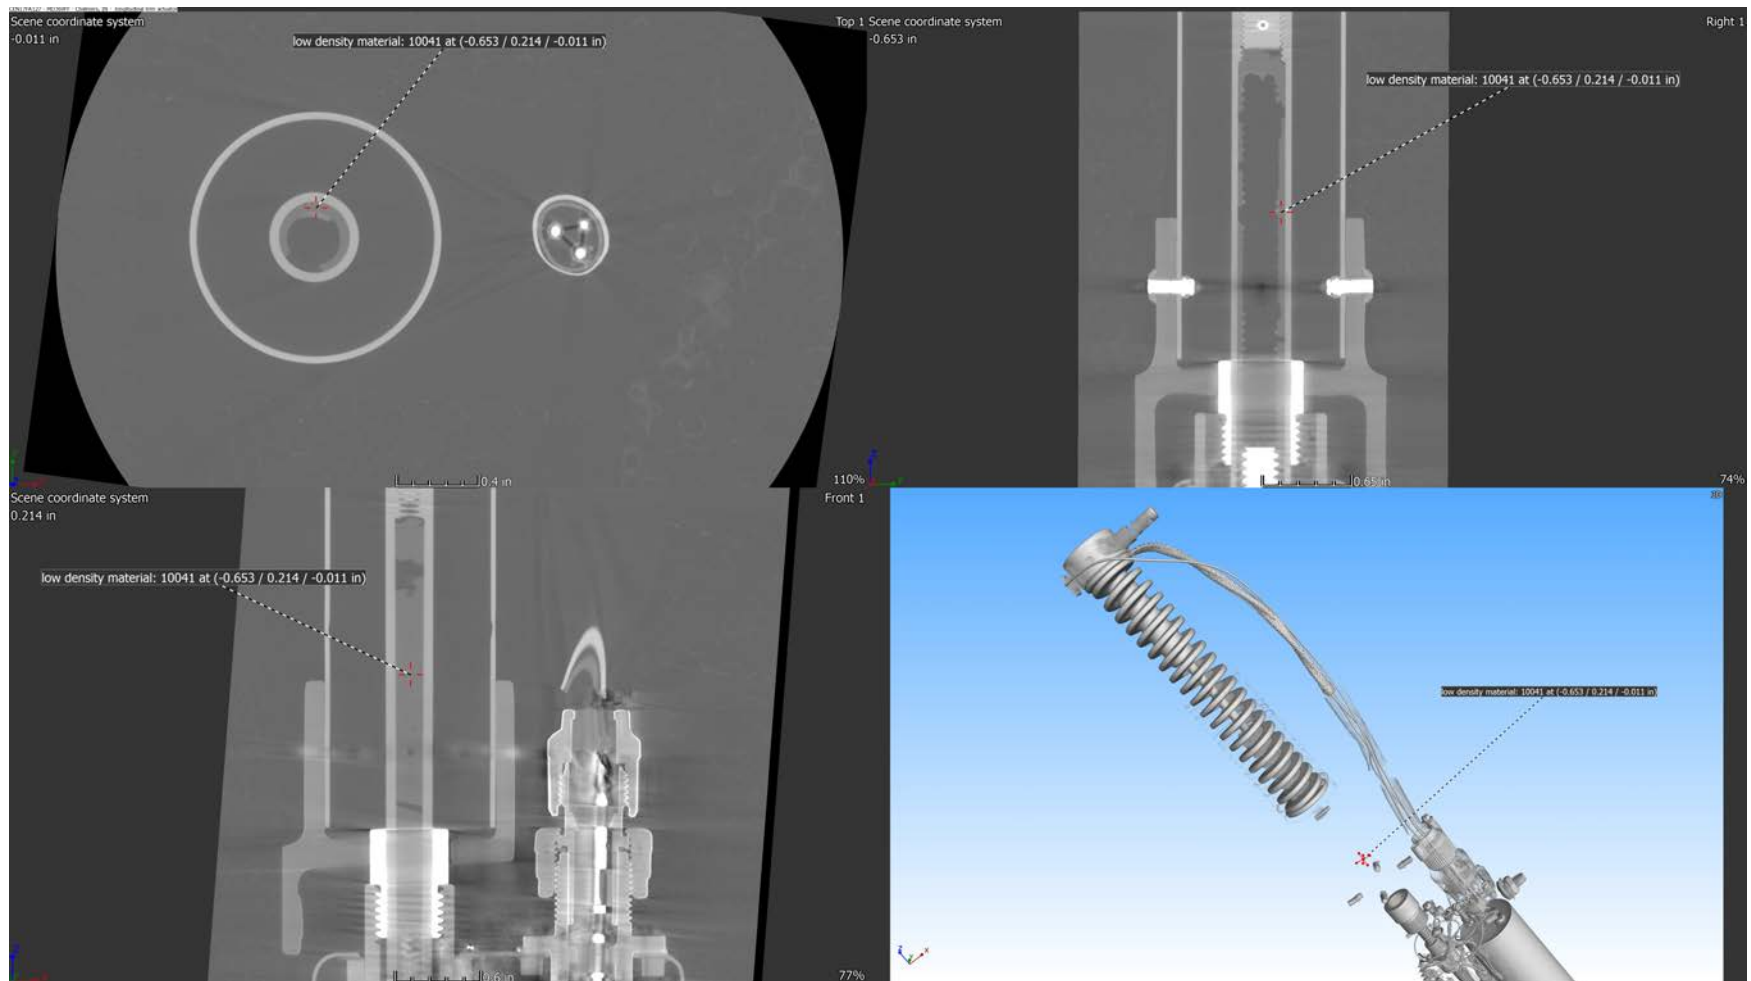
Figure 4
Longitudinal trim actuator – low density material

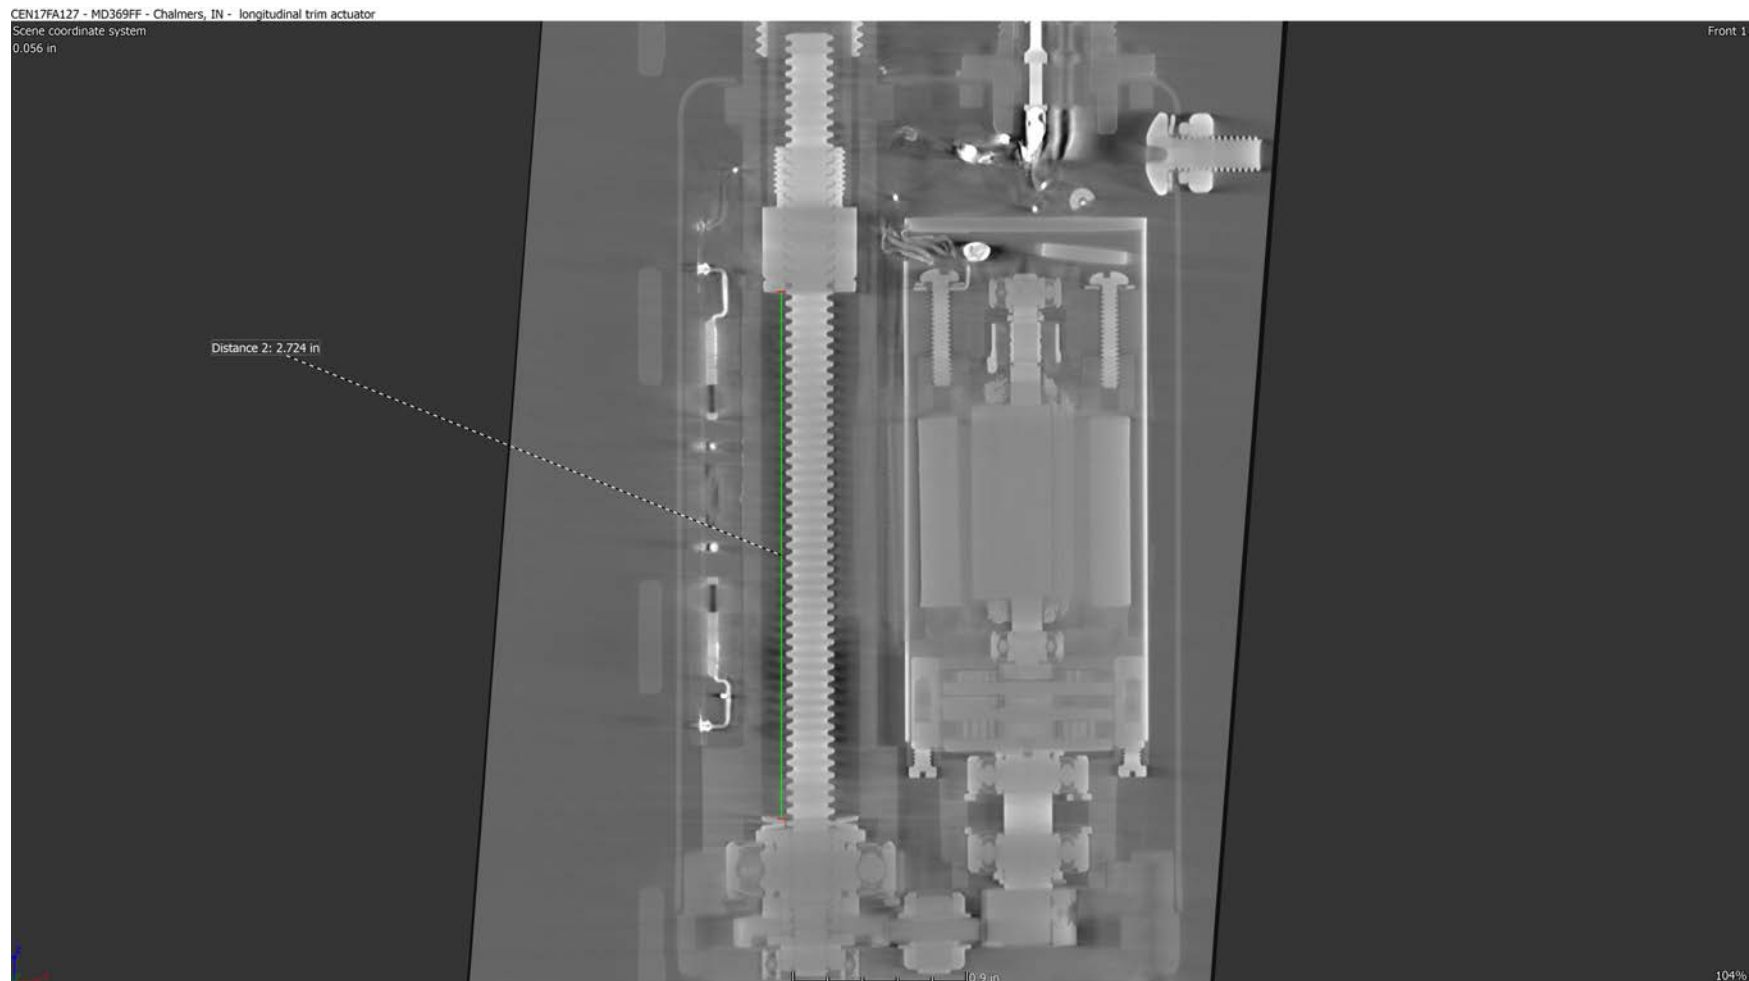
Figure 6
Longitudinal trim actuator – screw dimension

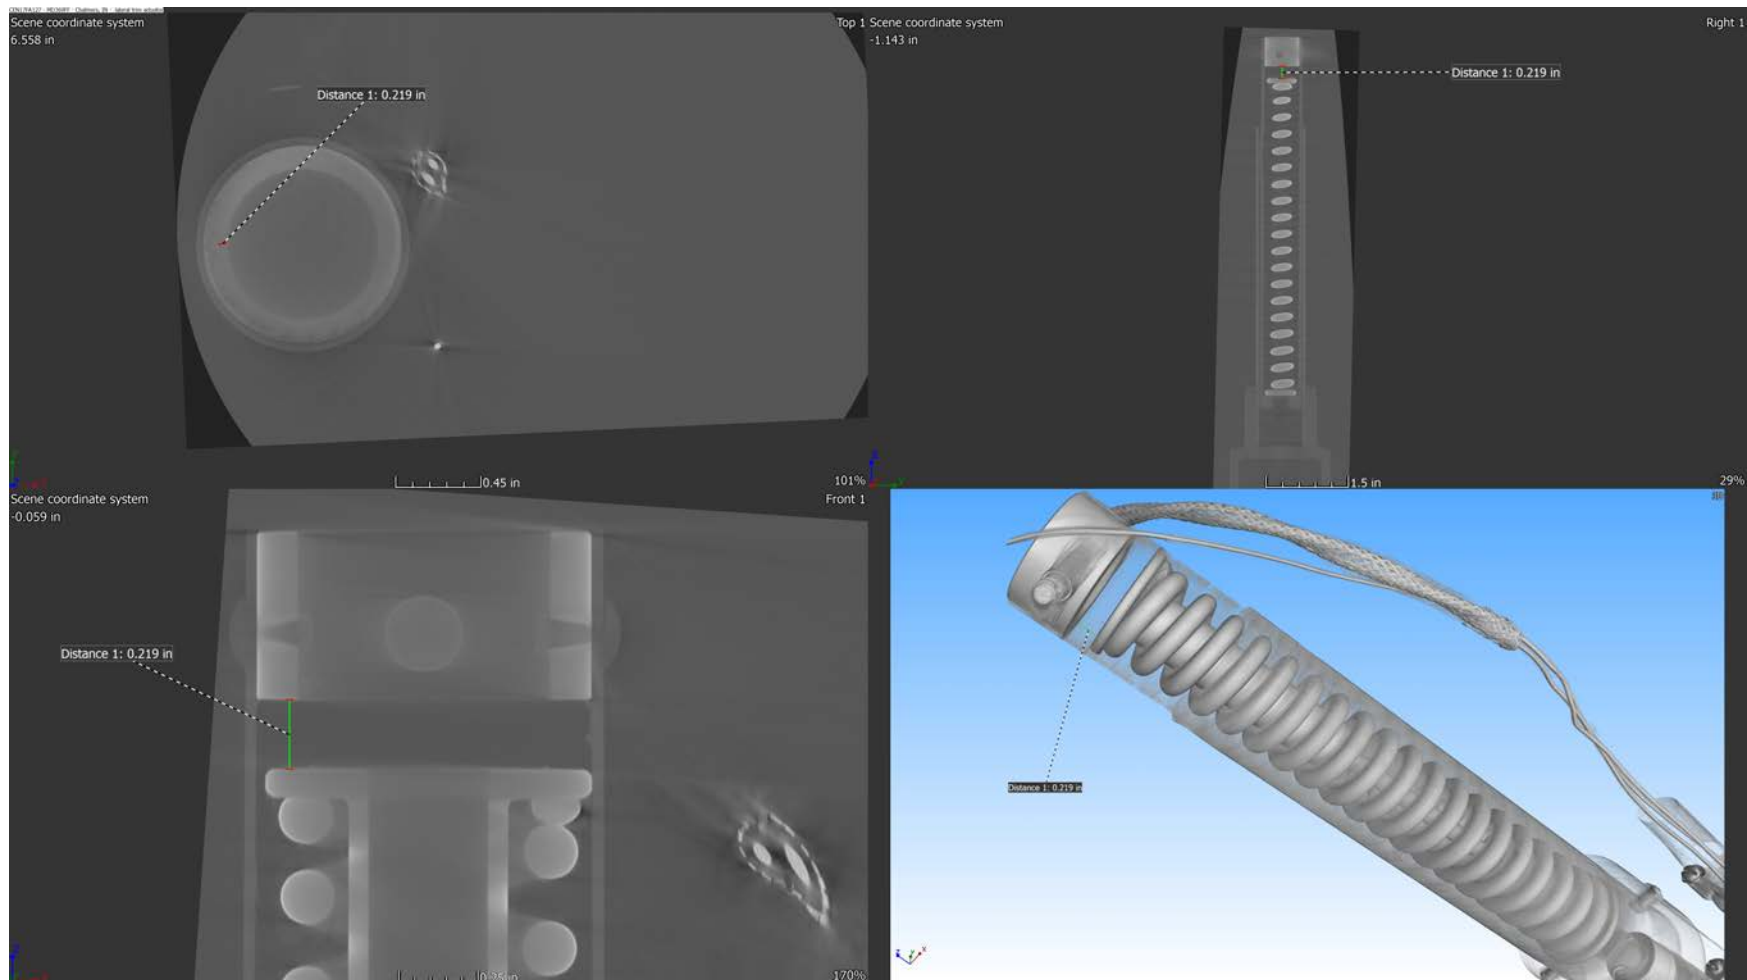
- there was a gap of 0.219 inches noted between the end of the actuator spring cartridge end fixture and the actuator rod end fixture;
- there were 0.517 inches of actuator screw thread between the actuator screw ball and the actuator screw base;
- there were no indications of failure within the actuator motor bearings or output gear train;
- there were no indications of short circuits or other wiring damage within the actuator motor or circuit board wiring;

Figure 47
Lateral trim actuator – gap

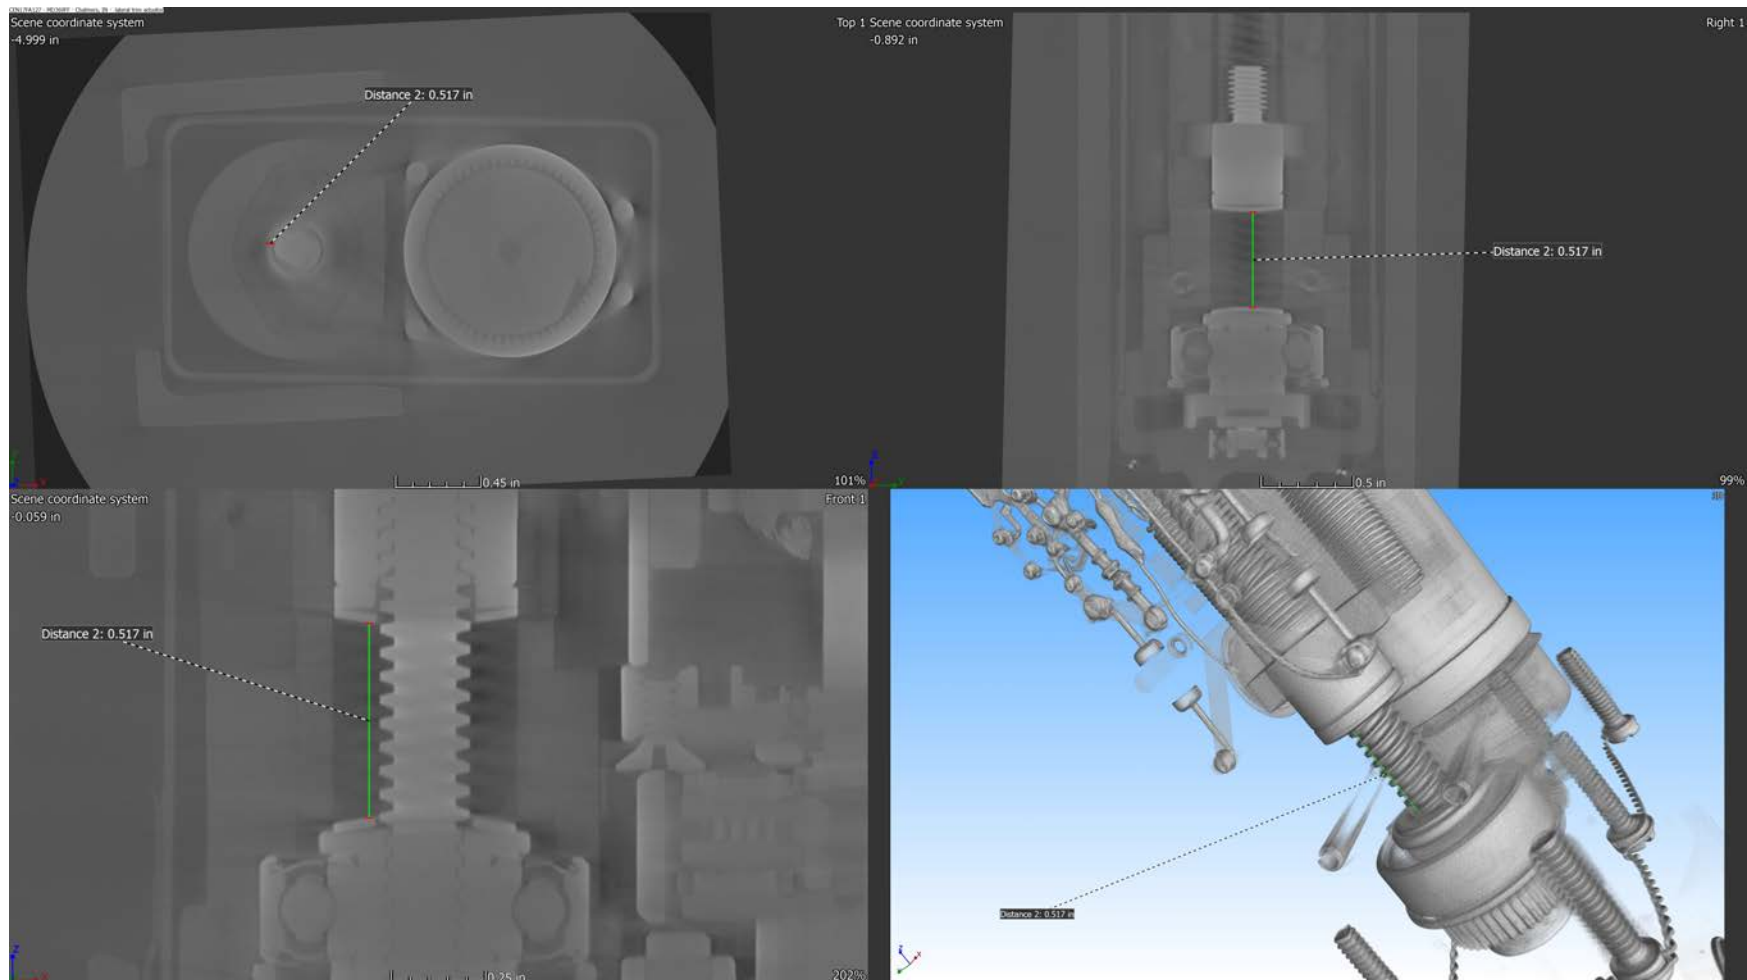
Figure 49
Lateral trim actuator – screw dimension

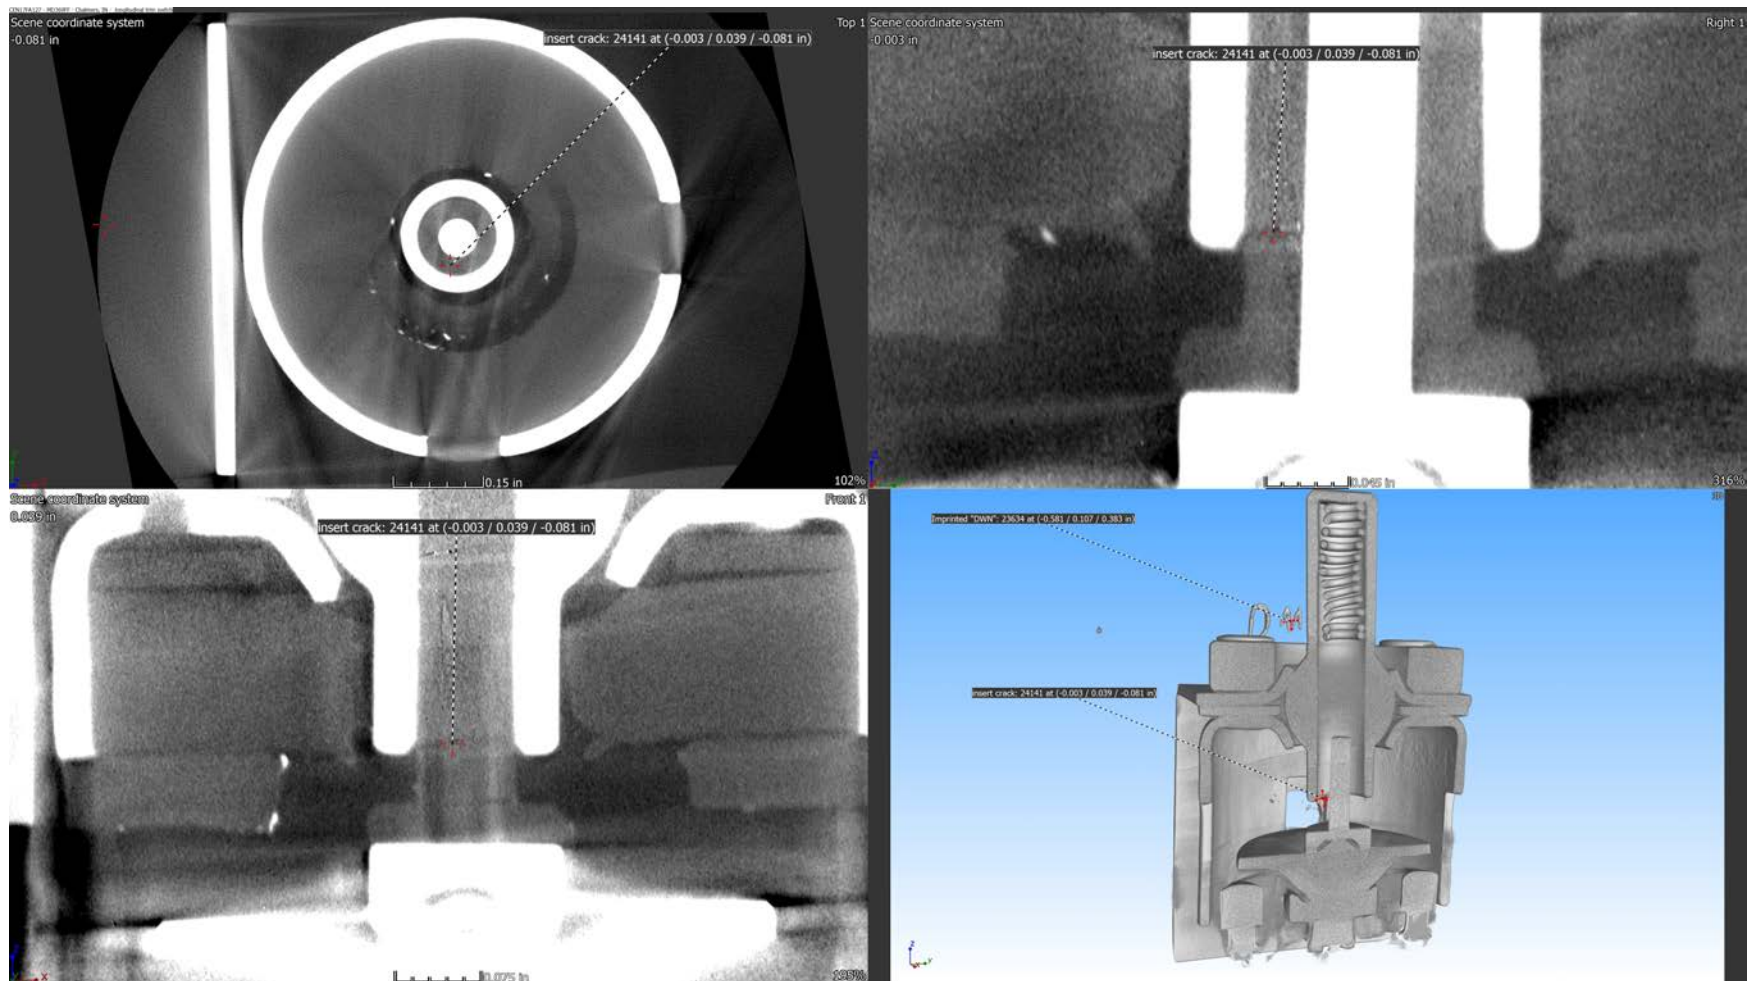
- there was a crack noted in the trim switch insert;

Figure 76
Trim switch – target CT – insert crack

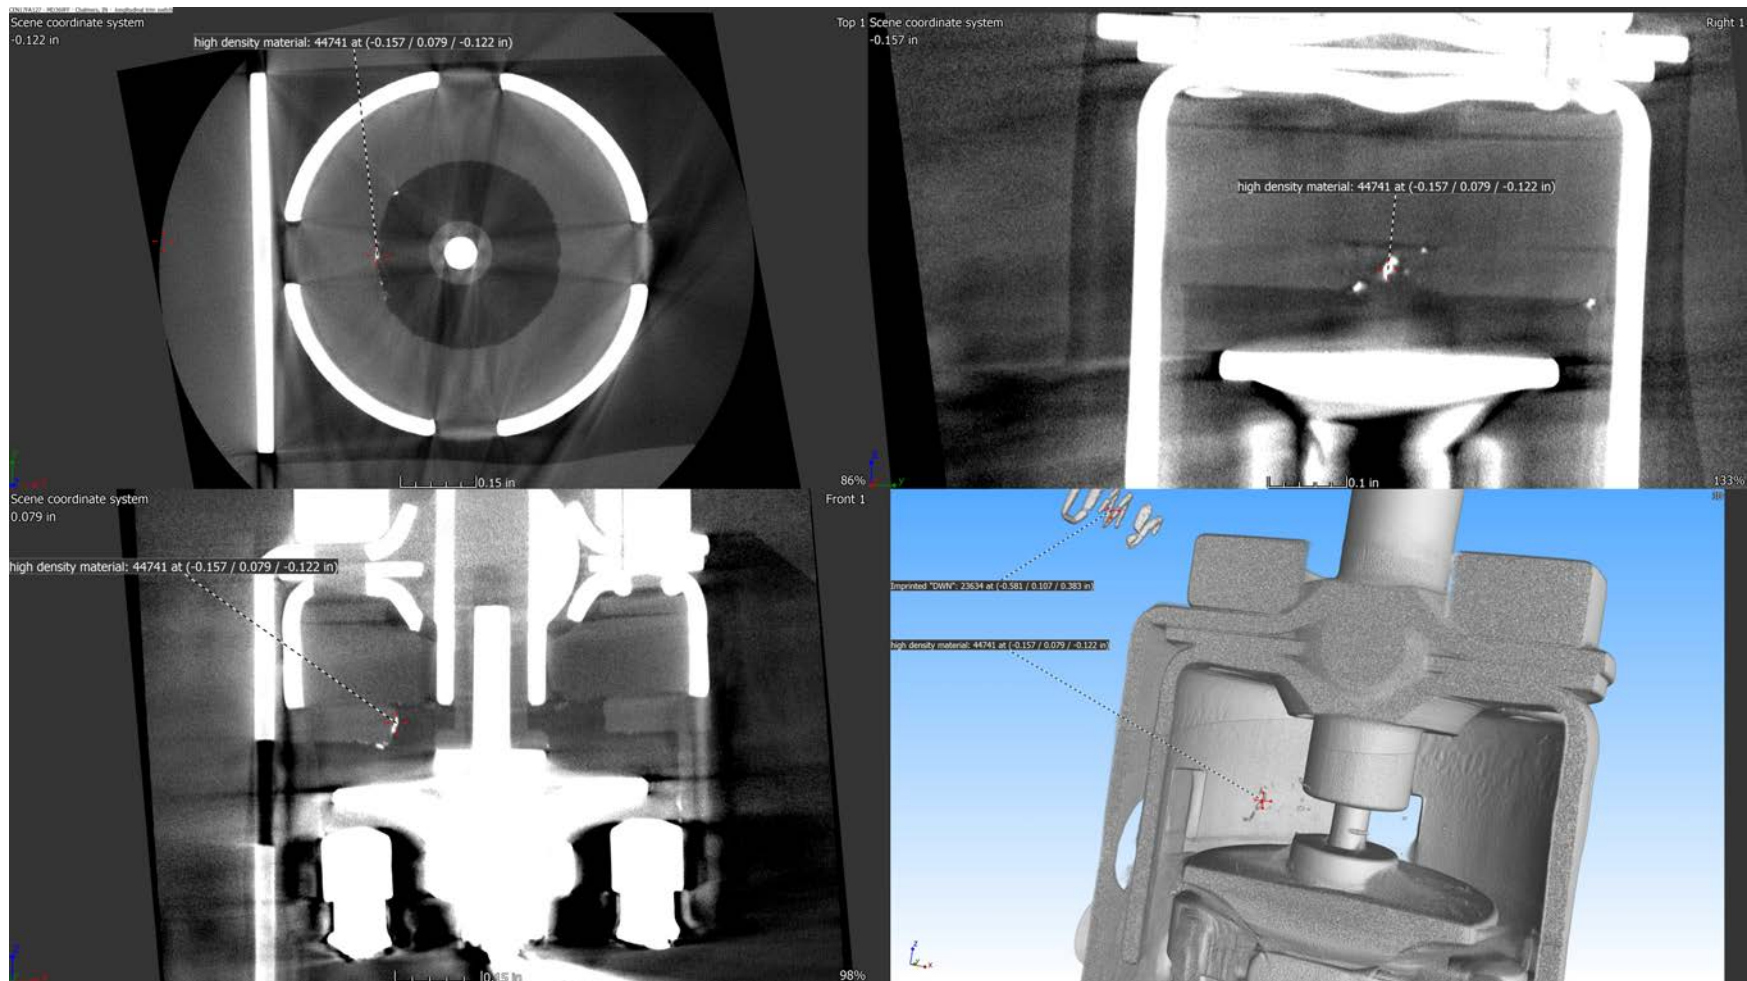
- there were multiple indications of high density particles within the trim switch;
- there were no indications of a material buildup that would have caused a short circuit within the trim switch.

Figure 77
Trim switch – target CT – high density material

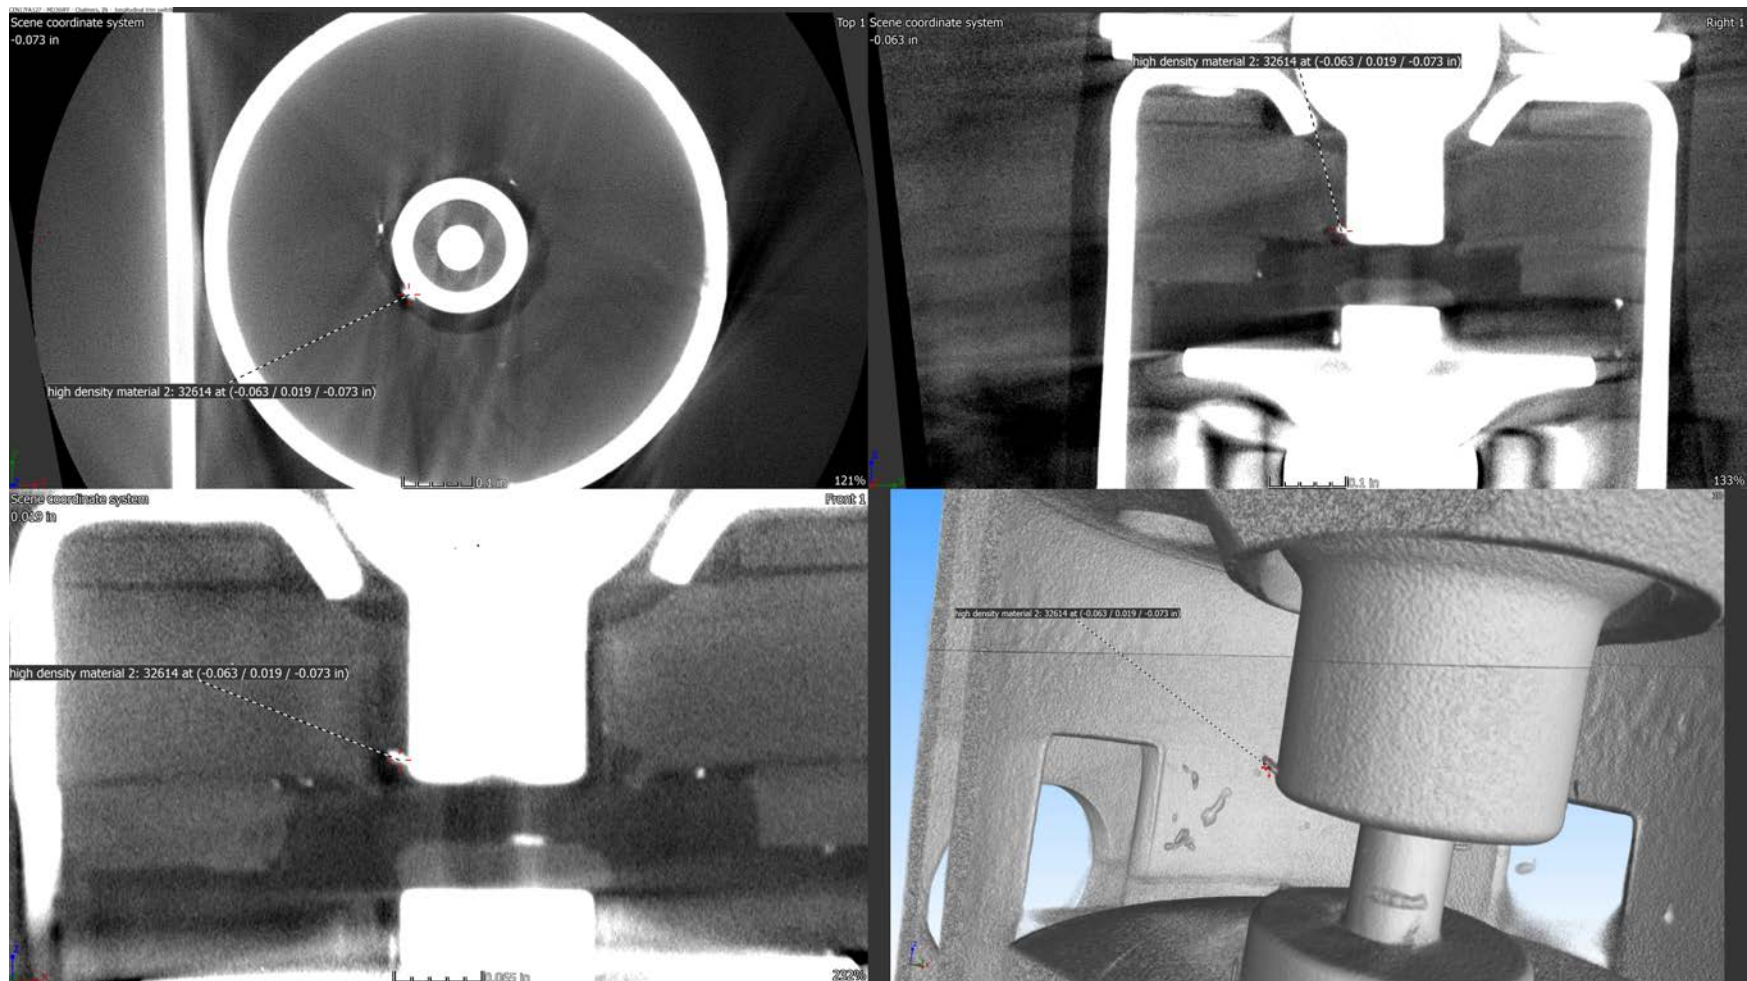
Figure 78
Trim switch – target CT – high density material 2

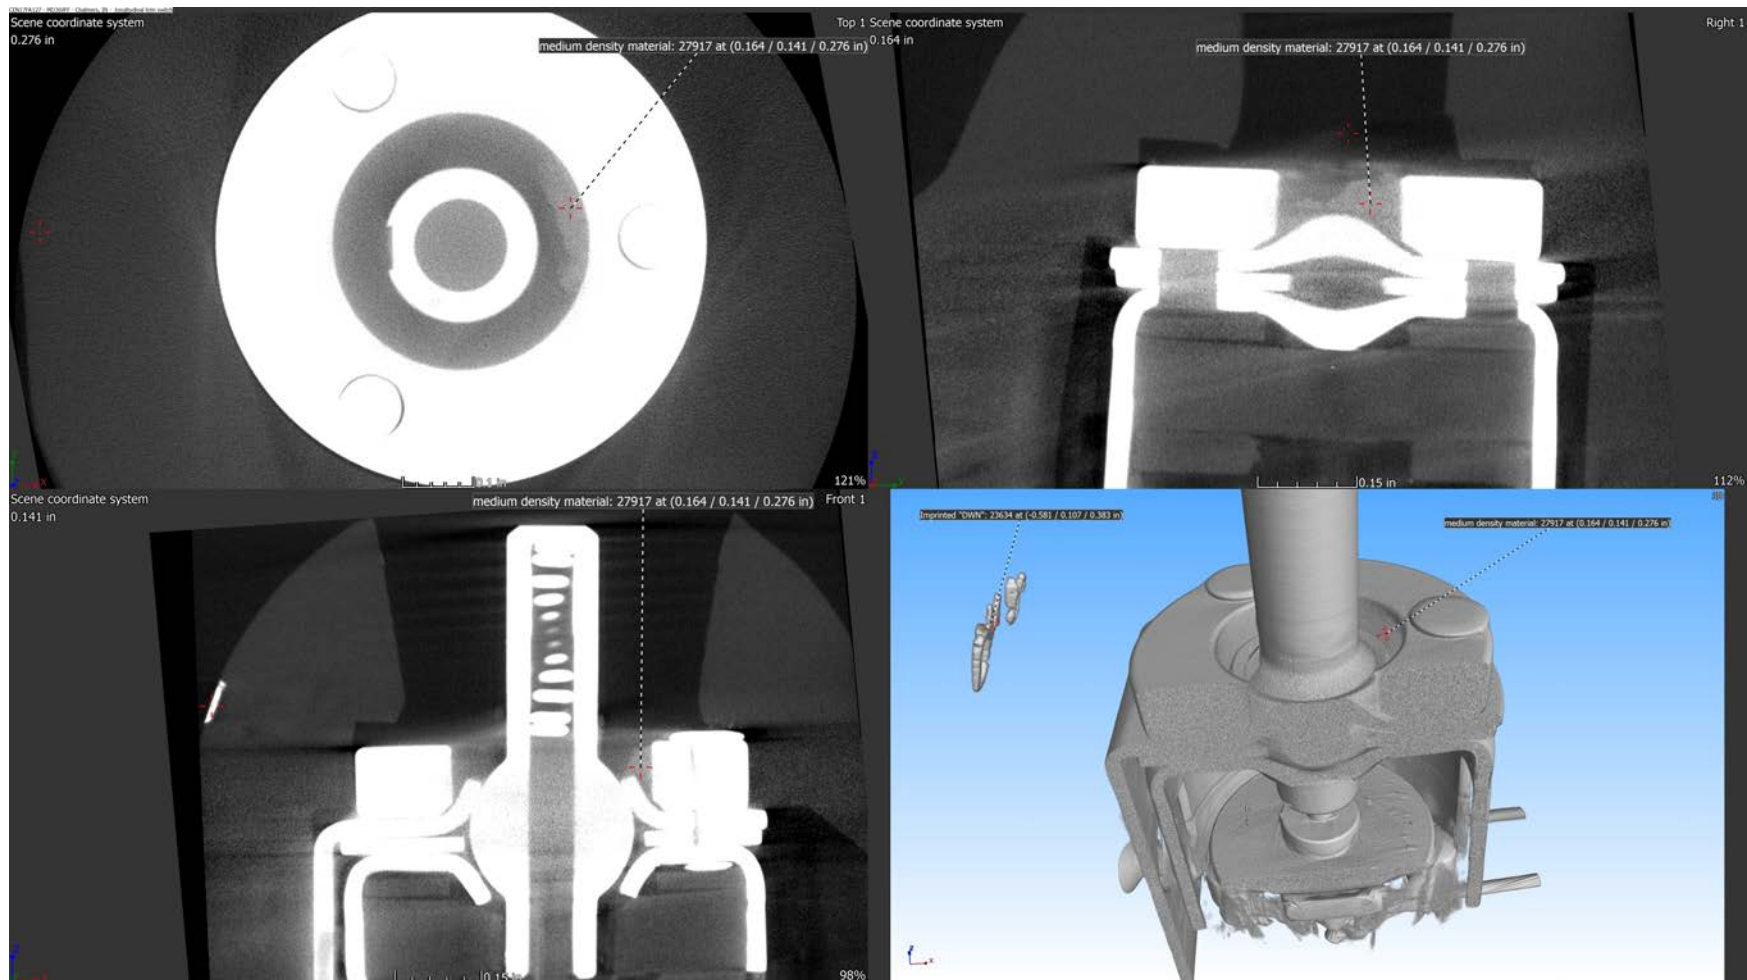
Figure 79
Trim switch – target CT – medium density material

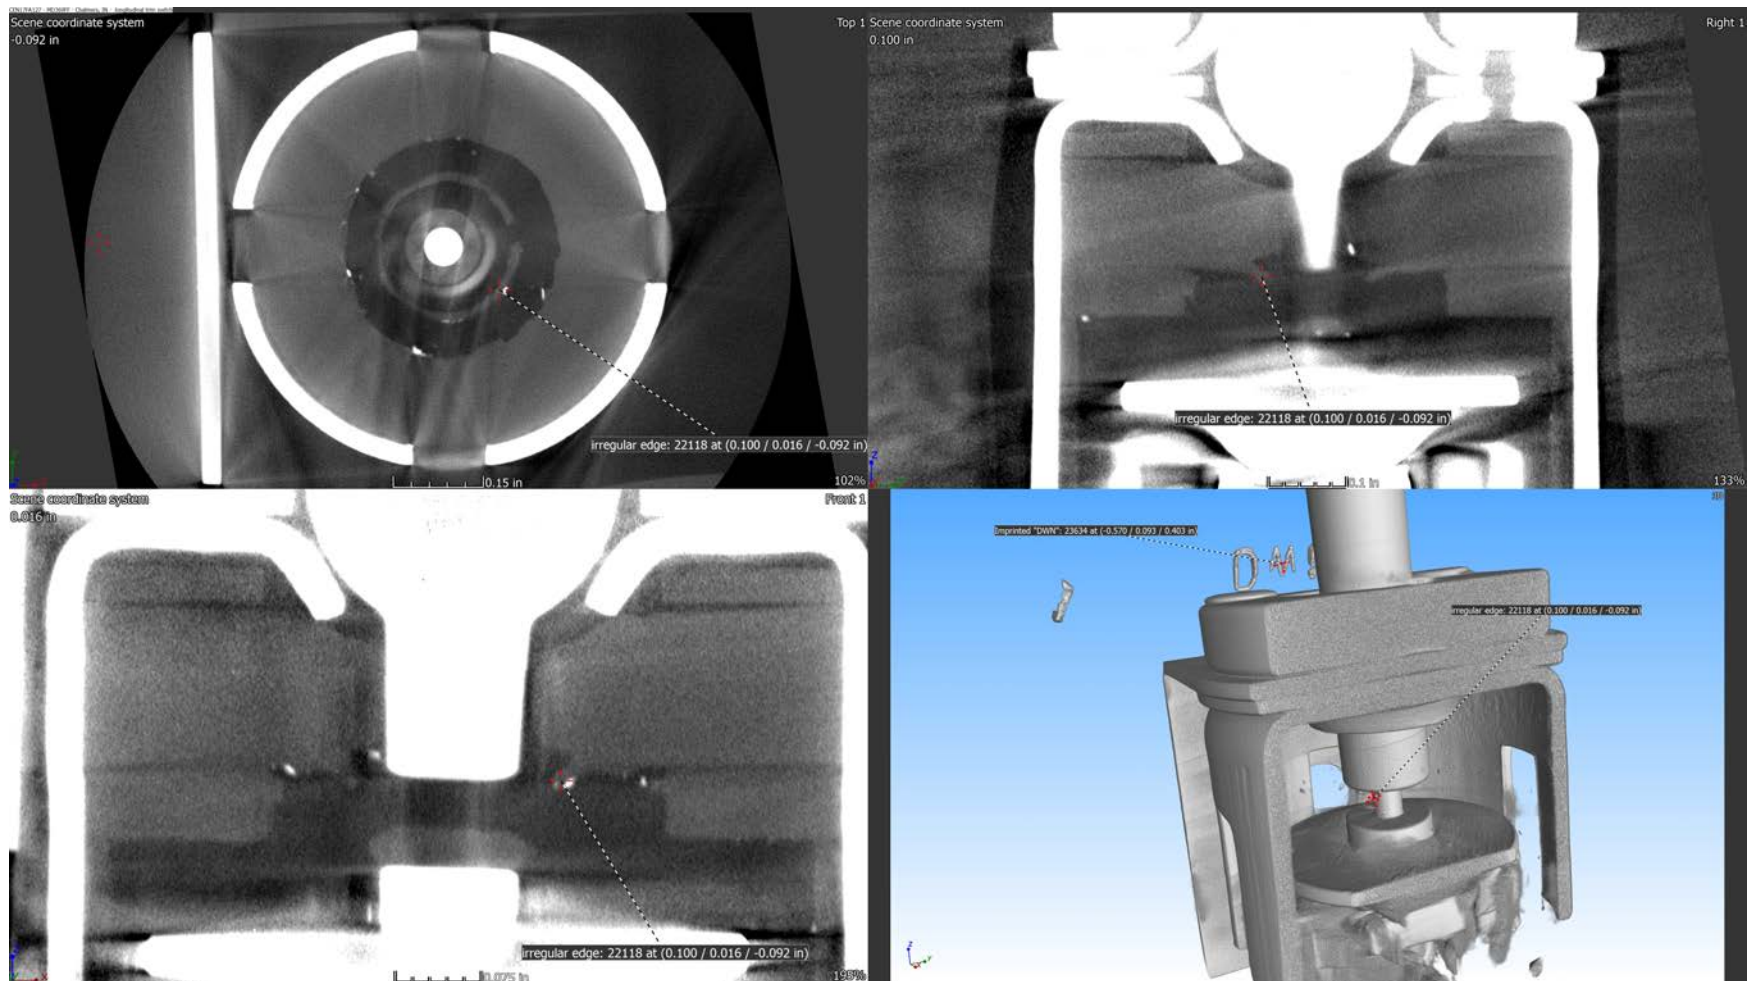
Figure 81
Trim switch – target CT – irregular edge
